Company Name: R. Mead Phase 1 (Swindon) Management Company Limited

Inspector Name: Thomas Dellow AIRPM

Inspection Date: 09 February 2023

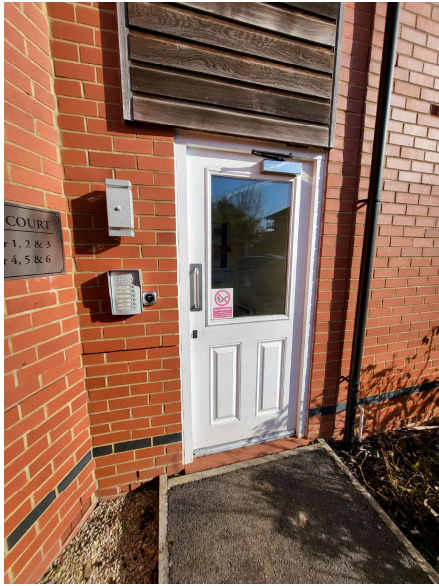
Entrances (Main Doors)

Internal Inspection	Acceptable	Not Acceptable	N/A	Comments	Action
Entrances (Main doors)	✓			The main entrances are secured via fob entry and were secure at time of inspection.	None
Hallway (Communal Lobbies and Stairs)	✓			The hallways appeared in good visual condition and were accessible.	None
Lighting (Standard and Emergency Lighting)	✓			The lighting appeared in good visual condition, emergency tests are carried out monthly and recorded.	None
Internal Doors (Compartment Doors)	✓			The internal compartmenting doors were operational.	None
Cupboard Doors (Electrical Cupboard Doors)	✓			The electrical cupboard doors were secure.	None
Windows (Communal Windows)	✓			The communal windows were in good visual condition.	Review
Signage (Communal Notices)	✓			The notice boards were updated and were accessible.	None
Additional Comments					None

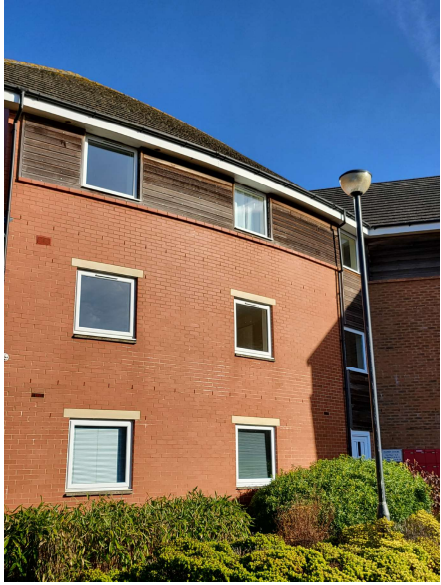
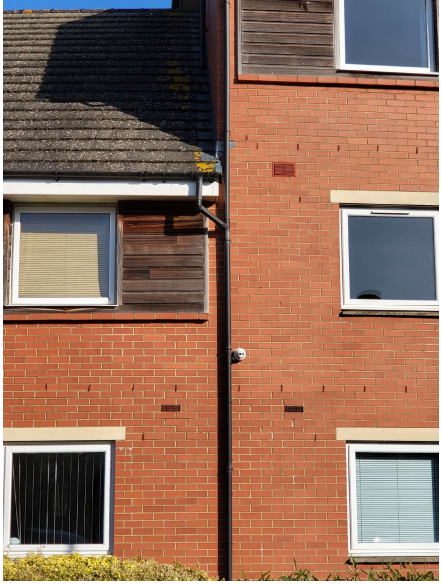
Exterior Structure (The Building)	Guttering (Gutters and Fascia)	Roofing (Tiles and Cladding)	Communal Grounds (Gardens and Common Areas)

External Inspection	Acceptable	Not Acceptable	N/A	Comments	Photos
Exterior Structure (The Building)	✓			The exterior appeared in good visual condition.	None
Guttering (Gutters and Fascia)	✓			The gutters appeared in good visual condition.	None
Roofing (Tiles and Cladding)	✓			Scaffolding was present outside Peony House following roofing works. It is due to be removed shortly. No other issues were visible.	None
Communal Grounds (Gardens and Common Areas)	✓			The gardens were well kept. A few fly-tipped items were noted on the communal grounds and will be removed shortly.	Review
Bin Store (Waste Disposal Areas)	✓			The bin store was tidy.	None
Car Park (Vehicle Parking)	✓			The car park was accessible. It was noted that some vehicles appear abandoned and will be ticketed.	Review
Bike Store (Bicycle Areas)		✓		Fly-tipped items were being stored in the bike store and will be removed.	Review
Additional Comments					None
