**Company Name:** R. Mead Phase 1 (Swindon) Management Company Limited

**Inspector Name:** Thomas Dellow MIRPM

**Inspection Date:** 25 October 2023

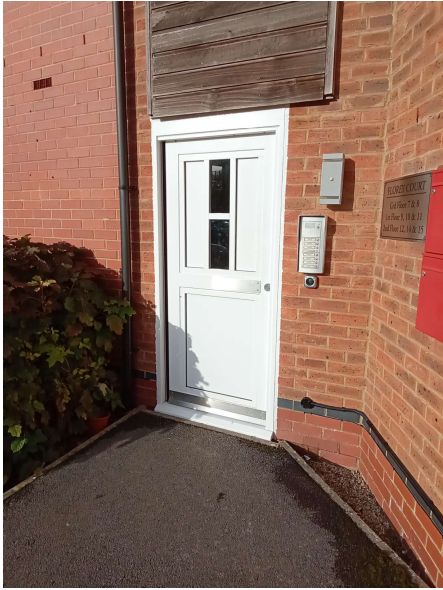
**Entrances (Main Doors)**

Internal Inspection	Acceptable	Not Acceptable	N/A	Comments	Action
<b>Entrances</b> (Main doors)	✓			Entrances were secure at time of inspection. The mag locks would benefit from adjustment for ease of access, an engineer has been engaged to review	Review
<b>Hallway</b> (Communal Lobbies and Stairs)	✓			The hallways were accessible and in good visual condition. It was noted that some items are being stored in the areas and should be removed.	Review
<b>Lighting</b> (Standard and Emergency Lighting)	✓			A 'flick test' was carried out with minor remedial action noted. Consideration could be given to replace the units with modern sensor LED.	Review
<b>Internal Doors</b> (Compartment Doors)	✓			The internal compartmenting doors were accessible and in good visual condition.	None
<b>Cupboard Doors</b> (Electrical Cupboard Doors)	✓			The cupboard doors were secured and accessible.	None
<b>Windows</b> (Communal Windows)	✓			The communal windows were in good visual condition. Consideration could be given to replacing restrictors.	None

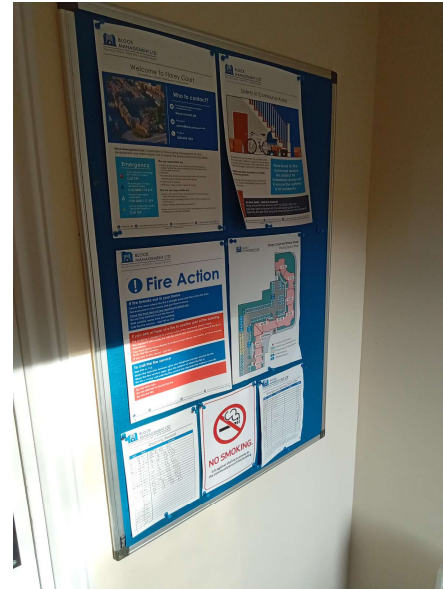
**Signage (Communal Notices)**

<b>Signage</b> (Communal Notices)	✓			The communal notice boards were accessible and up to date.	None
<b>Additional Comments</b>					None

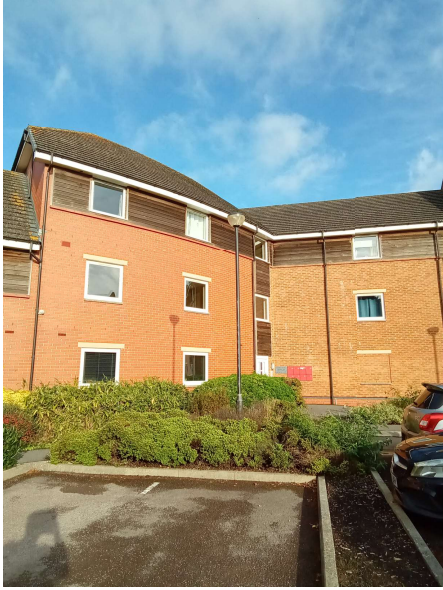
**Exterior Structure (The Building)**

External Inspection	Acceptable	Not Acceptable	N/A	Comments	Action
<b>Exterior Structure</b> (The Building)	✓			The exterior appeared in good visual condition.	None
<b>Guttering</b> (Gutters and Fascia)	✓			The guttering appeared in good visual condition.	None
<b>Roofing</b> (Tiles and Cladding)	✓			The roof was inspected at ground level and appeared in good visual condition.	None
<b>Communal Grounds</b> (Gardens and Common Areas)	✓			The communal grounds were tidy and accessible. Consideration could be given to replanting some areas where plants have died off.	Review
<b>Bin Store</b> (Waste Disposal Areas)	✓			The bin stores appeared in good visual condition.	None
<b>Car Park</b> (Vehicle Parking)	✓			The car park was accessible.	None
<b>Bike Store</b> (Bicycle Areas)	✓			The bike stores were accessible.	None
<b>Additional Comments</b>					None
