**Company Name:** R. Mead Phase 1 (Swindon) Management Company Limited

**Inspector Name:** K. Zak

**Inspection Date:** 14 May 2025

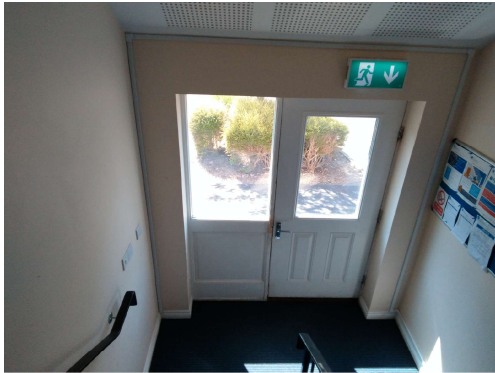
**Entrances (Main Doors)**

Internal Inspection	Acceptable	Not Acceptable	N/A	Comments	Action
<b>Entrances</b> (Main doors)	✓			Main entry doors were secure and functioning properly during inspection.	None
<b>Hallway</b> (Communal Lobbies and Stairs)	✓			Communal areas were tidy and in good visual condition.	None
<b>Lighting</b> (Standard and Emergency Lighting)	✓			Communal lighting was tested and confirmed to be fully operational.	None
<b>Internal Doors</b> (Compartment Doors)	✓			All internal fire doors were functional and free from visible damage.	None
<b>Cupboard Doors</b> (Electrical Cupboard Doors)	✓			Electrical and service cupboards were checked and found secure.	None
<b>Windows</b> (Communal Windows)	✓			All accessible windows operated correctly and closed securely.	None
<b>Signage</b> (Communal Notices)	✓			Mandatory safety signs were present and clearly visible.	None
<b>Additional Comments</b>					None

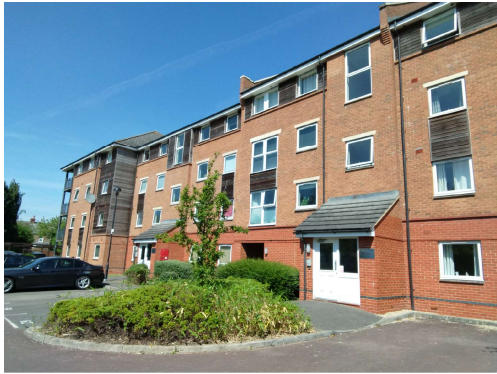
**Exterior Structure (The Building)**

External Inspection	Acceptable	Not Acceptable	N/A	Comments	Action
<b>Exterior Structure</b> (The Building)	✓			External inspection showed no cause for concern.	None
<b>Guttering</b> (Gutters and Fascia)	✓			Gutters and downpipes were secure and intact.	None
<b>Roofing</b> (Tiles and Cladding)	✓			No visible displacement or missing elements noted from ground view.	None
<b>Communal Grounds</b> (Gardens and Common Areas)	✓			Communal areas showed signs of regular care and upkeep.	None
<b>Bin Store</b> (Waste Disposal Areas)	✓			Bins were correctly used and showed no signs of overflow.	None
<b>Car Park</b> (Vehicle Parking)	✓			Car park is well-maintained, with no surface damage or obstructions.	None
<b>Bike Store</b> (Bicycle Areas)	✓			Bike store was accessible and free from clutter or obstruction	None
<b>Additional Comments</b>					None
