# COMBINED FIRE AND HEALTH & SAFETY RISK ASSESSMENT.

Address of premises:	Florey Court / Peony House Swindon SN1 4GX
Responsible Person:	Florey Court and Peony House RTM Company Ltd
Duty Holder:	Block Management Limited
Person(s) consulted:	No occupier or other relevant person available to consult.
Assessor:	Rob Cockburn
Report validated by:	John Godfrey, GFireE.
Date of fire risk assessment:	6 <sup>th</sup> March 2025/ Reviewed March 2026
Date of previous fire risk assessment:	14 <sup>th</sup> March 2023
Suggested date for review:	March 2027

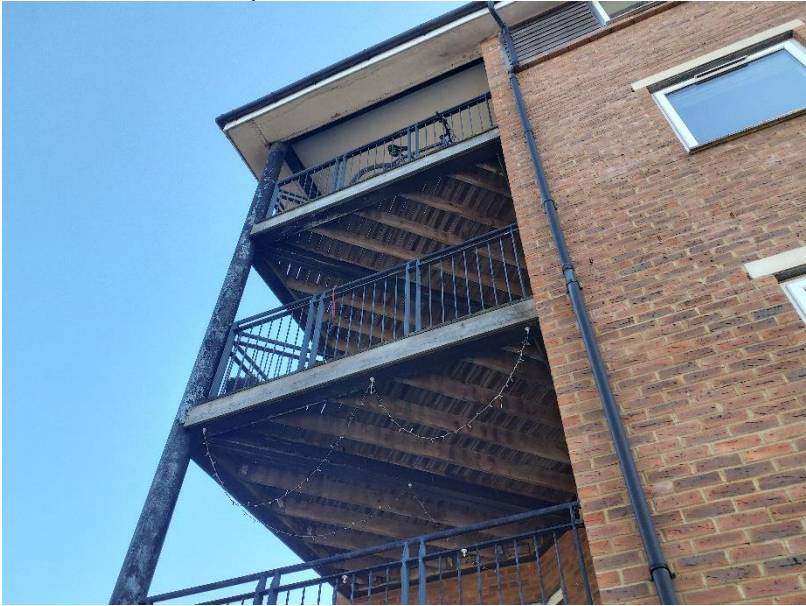
Item	Recommendation	Priority	Timescale	Action required
01	<p>No attempt has been made to intrusively investigate the conformity of the external wall construction against the requirement of relevant benchmark standards including Approved Document B. As the external wall structure appears to comprise of cladding with an unknown resistance to surface flame spread, it is recommended that the RP instruct a competent person to commission a FRAEW in accordance with the requirements of the Fire Safety Act 2021. The results of this assessment should then be attached to future FRAs.</p>	1	B	<p>Action required EWS1 form available. Red cedar clad is BSEN1350 1-1 Class - s2 (very limited contribution to fire)</p>
02	<p>It was noted during this assessment that numerous balconies have timber flooring. It is recommended that these timber balconies be upgraded or replaced with suitable fire-resistant materials capable of providing a minimum of thirty minutes fire resistance in order to reduce the external spread of fire.</p>

2	B	<p>Action required DH to obtain further advice.</p> <p>Balcony owners are provided with additional safety information.</p>

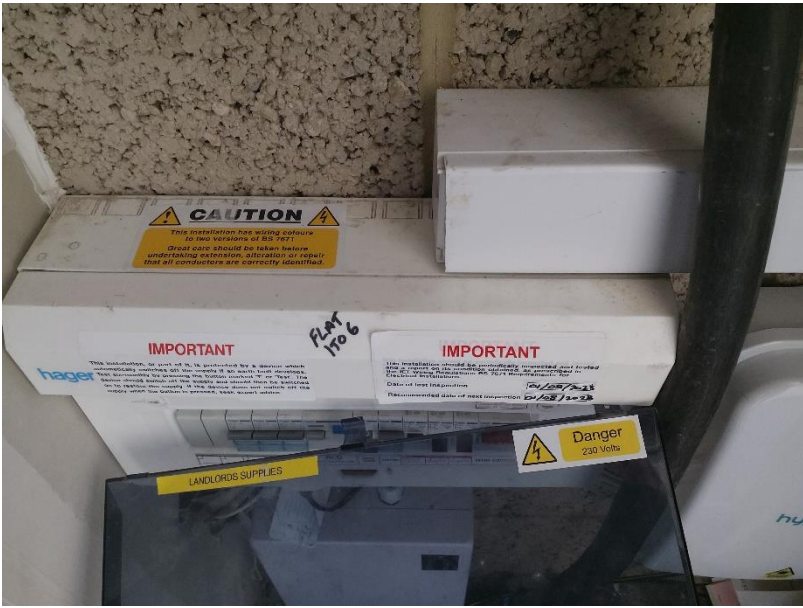
<p>03</p>	<p>According to the sticker attached to the consumer unit, the fixed electrical installation was last inspected and tested in August 2023. All fixed electrical installations supplying the communal areas of a residential property should be inspected and tested by a competent person every five years in accordance with Electricity at Work Regulations / IEE Wiring Regulations Eighteenth Edition 2019 / British Standard 7671: 2018 and a written Electrical Condition Report (EICR) obtained. It is recommended that the RP create a management action to ensure the electrical installation is retested on a five yearly rolling basis.</p>

<p>3</p>	<p>C</p>	<p>Ongoing action required DH maintain central record of EICR due dates  Due 2028</p>
<p>04</p>	<p>The communal areas are heated by wall mounted electrical heaters, it is recommended that these be inspected and tested by a competent person in line with the fixed electrical installation.</p>

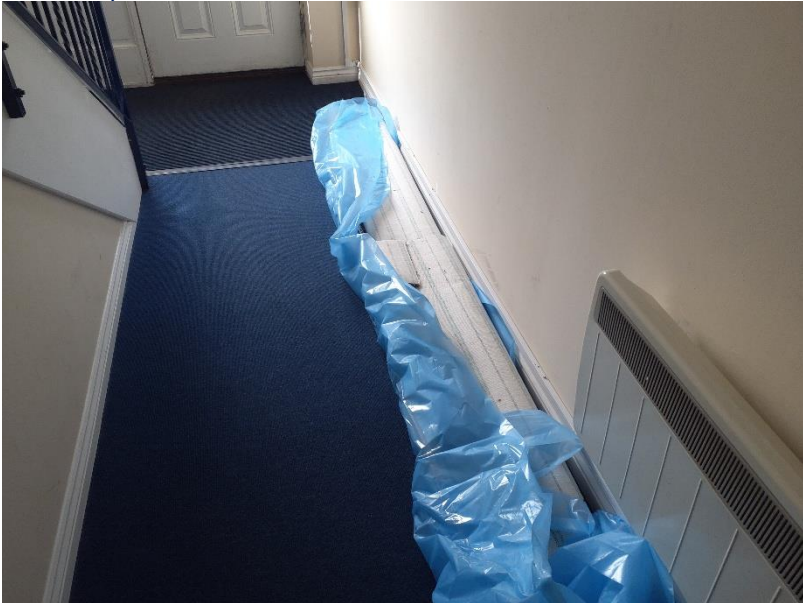
<b>05</b>	<p>Housekeeping was found to be satisfactory at the time of this assessment within Block 1-6, Block 7-15, Block 16-24, Block 25-40, Block 54-61, Block 62-64 and Peony House, with all common areas and escape routes found to be free of combustibles and residents' storage. Care must be taken to avoid obstructing or blocking fire exit routes and this area must be monitored at all times.</p>	3	C	<p>Ongoing action required DH inspect communal areas</p>
<b>06</b>	<p>Housekeeping was found to be of a poor standard at the time of this assessment within Block 41-45, Block 46-53, 65-72, with the communal areas and escape routes congested with residents' possessions and storage. It is recommended that the client arrange for the communal areas to be cleared as a priority and all residents reminded of the importance of maintaining sterile communal areas and escape routes.</p>

2	C	<p>Ongoing action required</p> <p>DH inspect communal areas and ticket items for removal.</p> <p>Residents are reminded of sterile area policy via notice board</p>

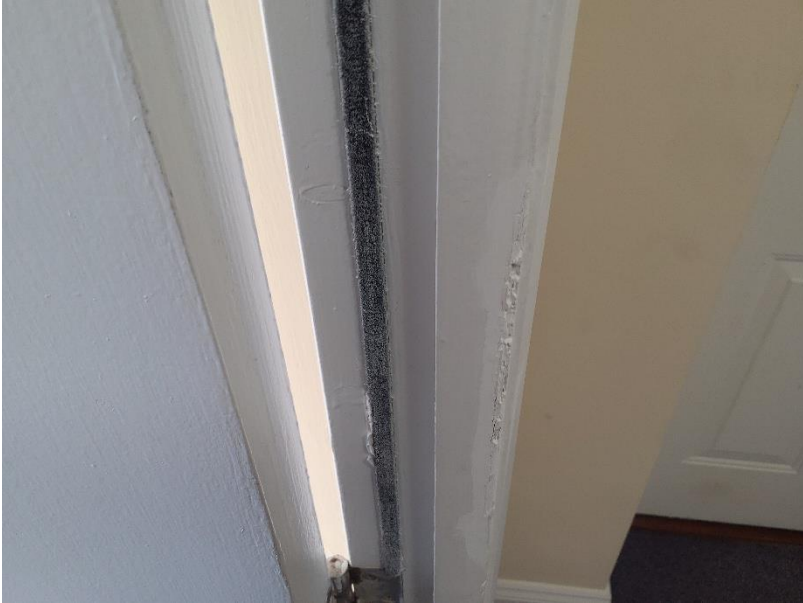
<p>08</p>	<p>It was noted during this fire risk assessment that numerous: lobby doors, riser doors and electrical intake cupboards within all blocks had painted seals. Paint on the cold smoke seal could affect the integrity of the seal which could allow smoke to pass into the means of escape. It is therefore recommended that the RP instructs a suitably qualified and competent contractor to replace all painted smoke seals with a new cold smoke seal to compliment the intumescent seal in order to protect the means of escape.</p>

<p>2</p>	<p>C</p>	<p>Ongoing Action required Contractor has investigated and replaced where required. To be monitored during inspections</p>
-----------	---	----------	----------	--

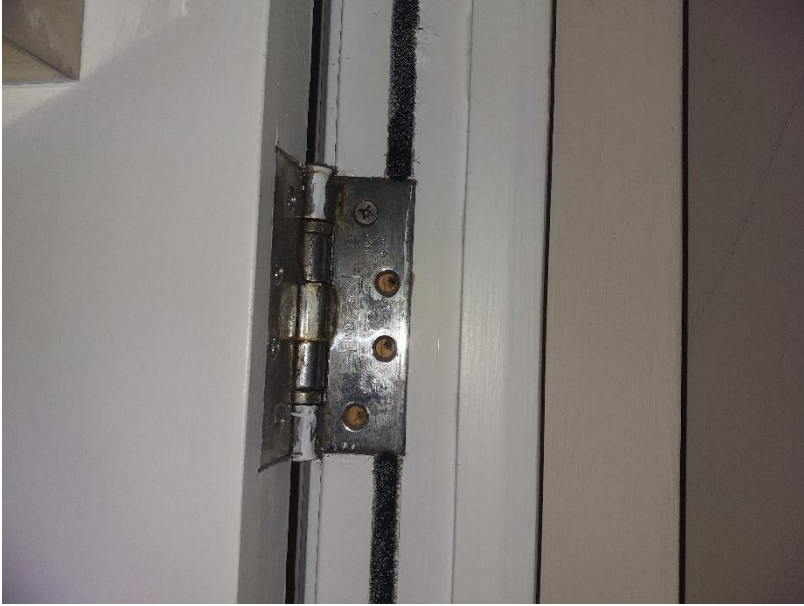
09	<p>It was noted during this fire risk assessment that screws were missing from the:</p> <ul style="list-style-type: none"><li>• bottom hinge of the second-floor riser door in block 16-24,</li><li>• top hinge of the second-floor riser door, every hinge of the second-floor right lobby door and bottom hinge of the ground floor right lobby door within block 25-40</li><li>• top hinge of the ground floor electrical intake cupboard and the bottom hinge of the first-floor riser door</li></ul> <p>This could affect the integrity of the door set in high temperatures which could allow smoke and fire to spread into the means of escape. It is therefore recommended that the RP instructs a suitably qualified and competent contractor to install new high temperature screws that are in tandem with the door set in order to protect the means of escape.</p>

3	B	Action complete
----	---	---	---	-----------------

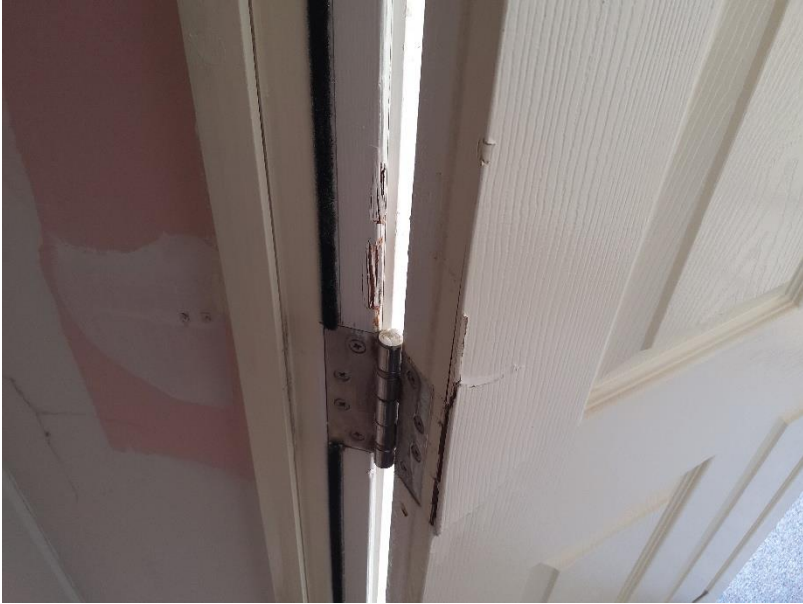
<p>10</p>	<p>It was noted during this fire risk assessment that the third-floor riser door within peony house had damage to the door and frame. It was further noted that the ground floor electrical intake cupboard door within Block 62-64 had damage to the internal side of the door. This could affect the integrity of the fire resistance of the door and frame which could allow smoke and fire to spread into the means of escape. It is therefore recommended that the RP instructs a suitably qualified and competent contractor to repair the damage to ensure 30 minutes fire resistance. If this cannot be achieved it is recommended that the damaged frame is replaced with a new frame capable of providing a minimum of 30 minutes fire resistance along with replacing both doors with a new FD30s fire door complete with: cold smoke and intumescent seals, three grade 13 hinges, an FB2 Lock and "Fire Door Keep Locked" signage.</p>

<p>2</p>	<p>B</p>	<p>Action complete</p>

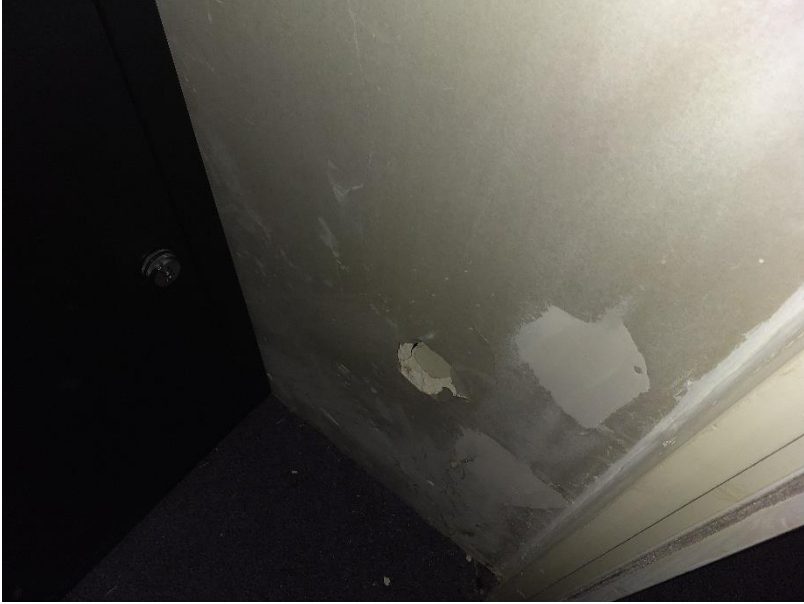
12	There were no disabled occupants identified during this assessment. In the event of a disabled person requiring access to the premises (i.e. an employee, a visitor or a contractor) a Personal Emergency Evacuation Plan (PEEP) should be written and implemented by the RP.	3	C	Ongoing action DH action as required
13	<p>It was noted during this fire risk assessment that there is a large breach within the electrical intake cupboard of block 16-24 which could allow smoke and fire to travel undetected through the premises. It is therefore recommended that the RP instructs a suitably qualified and competent contractor to repair the breach with a compound capable of providing a minimum of 30 minutes fire resistance in order to protect the means of escape.</p>

1	B	Action complete

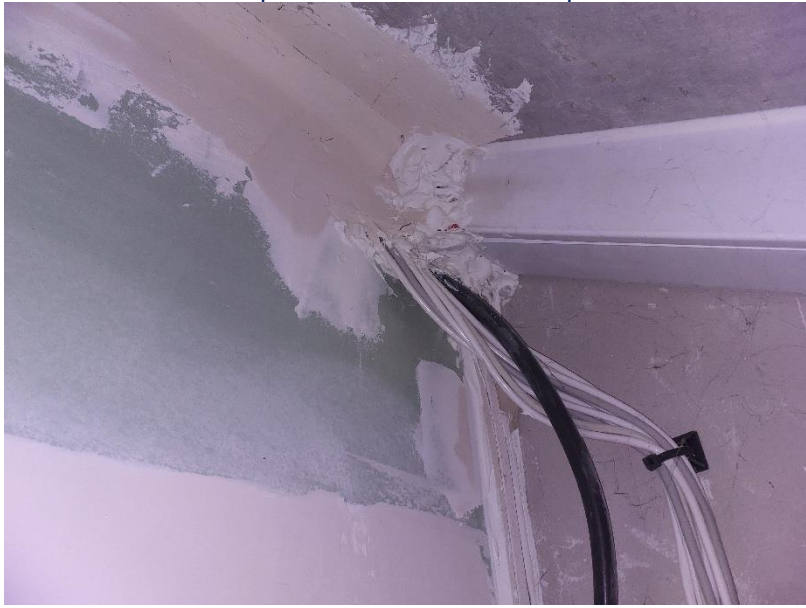
<p>14</p>	<p>It was noted during this fire risk assessment that there was an excessive use of intumescent sealant within the ground floor electrical intake cupboard of Block 65-72. Intumescent sealant is to be used only as a sealant as the integrity cannot be confirmed when used to fill large breaches due to the changes in viscosity. It is therefore recommended that the RP instructs a suitably qualified and competent contractor to repair the breach with a suitable compound capable of providing a minimum of 30 minutes fire resistance in order to protect the means of escape.</p>

<p>3</p>	<p>C</p>	<p>Action complete Removed and reduced where appropriate</p>
<p>15</p>	<p>It was noted during this fire risk assessment that there was a breach in the compartmentation from the handrail in Block 62-64 on the third floor. This could allow smoke and fire to pass undetected through the building which could block or impede persons escape. It is therefore recommended that the RP instructs a suitably qualified and competent contractor to repair the breach with a suitable compound capable of providing a minimum of 30 minutes fire resistance.</p>

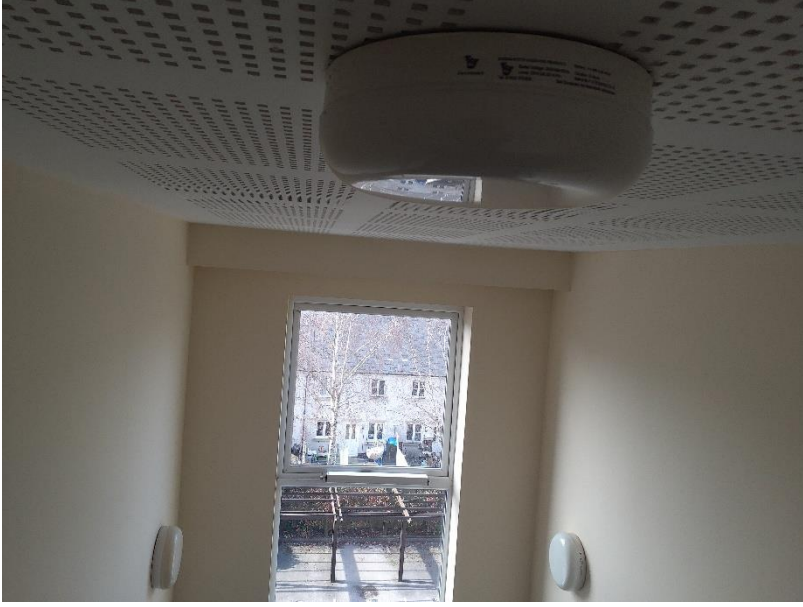
<p>16</p>	<p>Emergency lighting is installed within the common areas however many lights in multiple blocks appeared to not be charging. This could delay a safe and prompt evacuation in low ambient light conditions. It is recommended that the client consult with a competent contractor to conduct a light level assessment and emergency light fittings be repaired where required to ensure adequate emergency lighting levels of all escape routes.</p>

<p>1</p>	<p>B</p>	<p>Action complete</p> <p>N.B Lighting is a mix of emergency and non emergency. Electrician is working to replace all with new emergency lighting</p>
<p>17</p>	<p>Each flat is responsible for their own fire precautions and it is recommended that the RP advise each resident of the importance of installing smoke detectors within their flat. One battery operated smoke detector in the lobby of each flat would be the minimum provision, however mains powered smoke detectors, each with a battery backup, installed within the escape route of each flat, in all rooms that communicate with the escape route and a heat detector within the kitchen, interlinked to form a BS5839-6: 2019 Grade D detection system with LD2 coverage would be the preferred and safest option for each occupant.</p>	<p>3</p>	<p>C</p>	<p>Ongoing action required DH inform owners and via website</p>

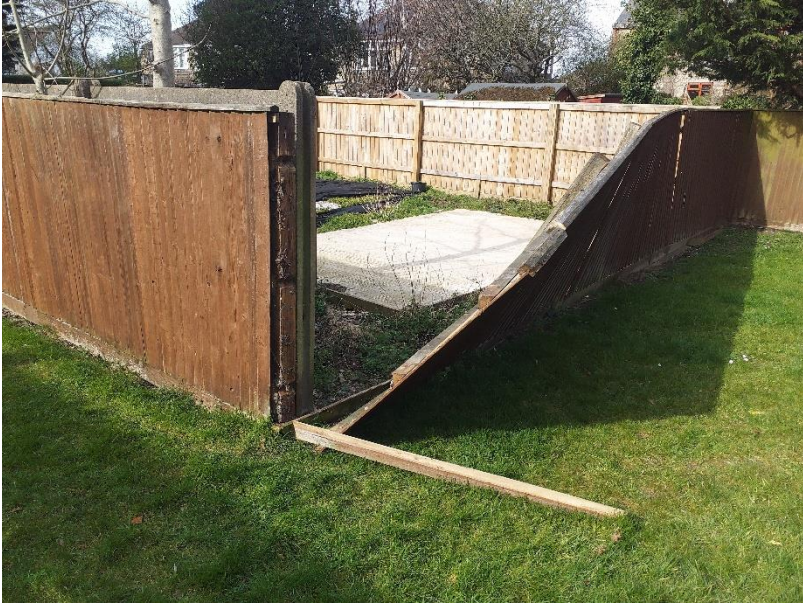
<p><b>23</b></p>	<p>It was noted during this assessment that a fence was damaged which could potentially causing a tripping risk and/or damage to the premises in high winds. It is therefore recommended that the fence is repaired as a matter of urgency.</p>

<p>2</p>	<p>B</p>	<p>Action required</p> <p>Fence belongs to neighboring property.</p> <p>Request has been made that this be repaired.</p>

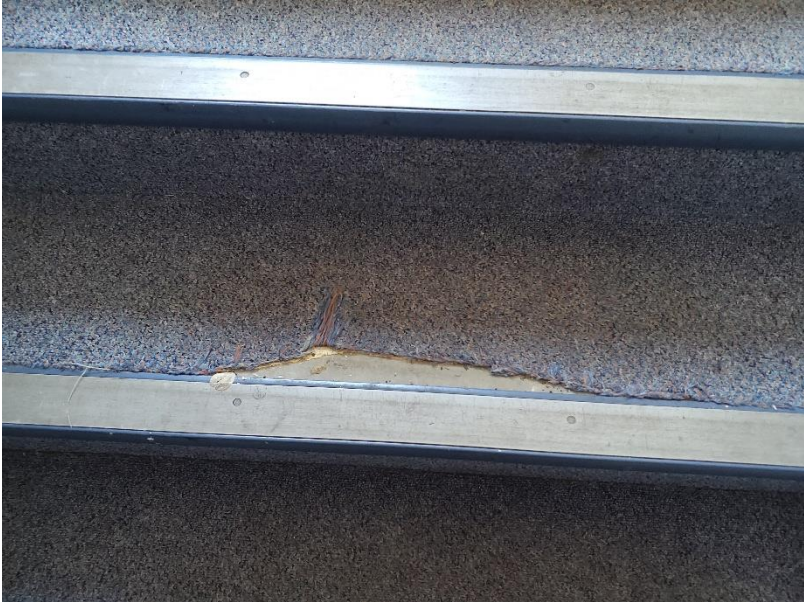
24	<p>It was noted during this assessment that the carpet tread on the staircase between the second and third floor in block 25-40 and the staircase between the ground and first floor in peony house was damaged which could cause a potential tripping risk. It is therefore recommended that the RP has the carpet repaired or replaced in order to stop any potential tripping risks.</p>

3	B	<p>Action required</p> <p>New carpet is scheduled to be installed across all blocks are part of rolling programme of works</p>
26	<p>It was noted during this assessment that handrail on the third floor of block 62-64 was not properly secured which could cause a potential fall. It is recommended that this handrail be repaired or replaced in order to reduce the risk of a fall.</p>

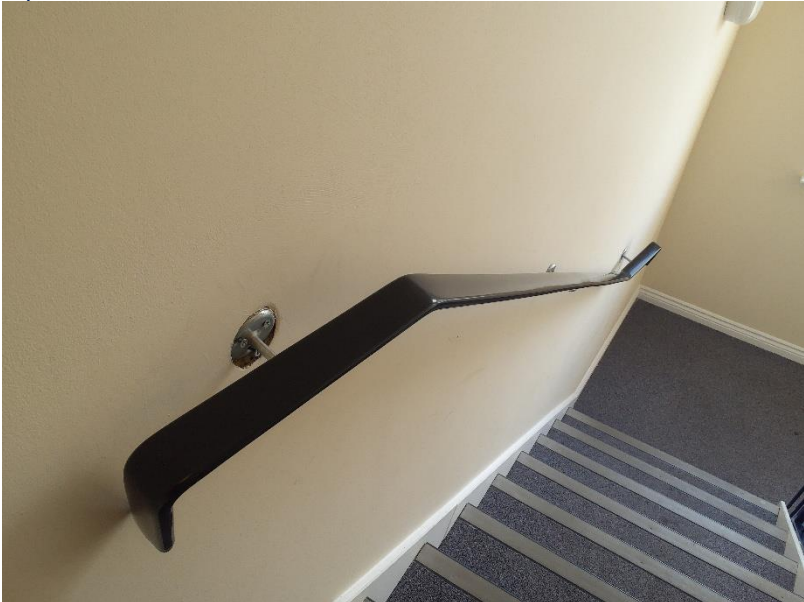
It was noted during this assessment that handrail on the third floor of block 62-64 was not properly secured which could cause a potential fall. It is recommended that this handrail be repaired or replaced in order to reduce the risk of a fall.

3	B	<p>Action complete</p>
